Evaluation of Coatings and Alloys to Extend the Lifetime of Equipment Used in Corrosive Environments

Gary Barone; David Smith; Marty Higgins, Restek Corporation, Bellefonte, PA

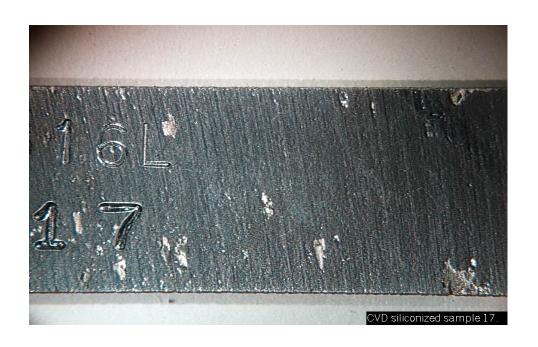
Figure 1a

Results from the pitting and crevice corrosion testing revealed that the silicon coated 316L stainless steel experienced no crevice corrosion and only slight pitting (figure 1a)

Table 1 summarizes weight loss resulting from exposure to the 6% w/w ferric chloride solution required by this method.

Elimination of crevice corrosion is an important step in reducing equipment depreciation in corrosive environments.

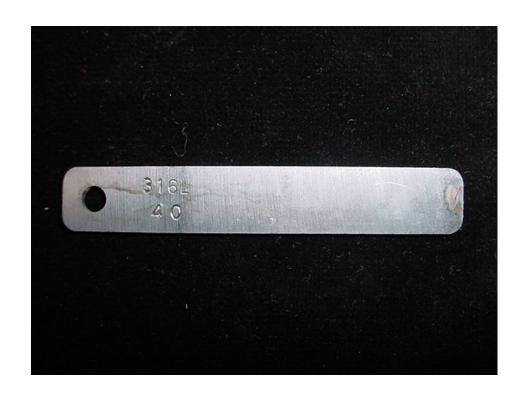
Figure 2a

The 1000 hour salt spray exposure did not have any effect on the silicon coated 316L stainless steel samples (figure 2a) The bare 316L stainless steel samples exhibited light surface rusting but no signs of pitting (figure 2b)

Results of this study indicate the potential application of Silcosteel®-CR to enhance product lifetime and reduce equipment maintenance in marine environments.

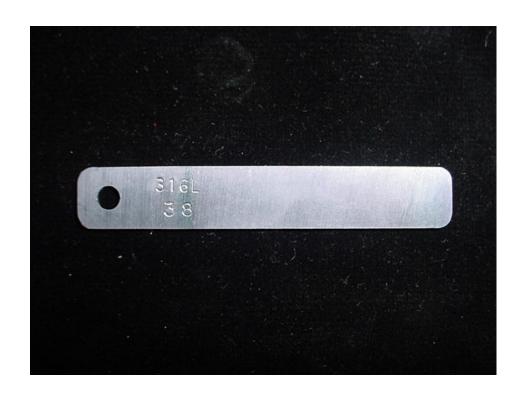
Figure 3a

Exposure to condensing humidity had no effect on the silicon coated 316L stainless steel coupon (figure 3a) and produced only a slight oxide layer on the bare 316L stainless steel coupon (figure 3b).

This testing proved the stability of the Silcosteel®-CR coating in an environment designed to simulate outdoor applications of the coatings.
